# Manhole Inspection Summary

Manhole # S25U\_\_002MH

Insp Date: **3/26/09 12:08 PM**

**Location** Address: **1600 Wicomico St**

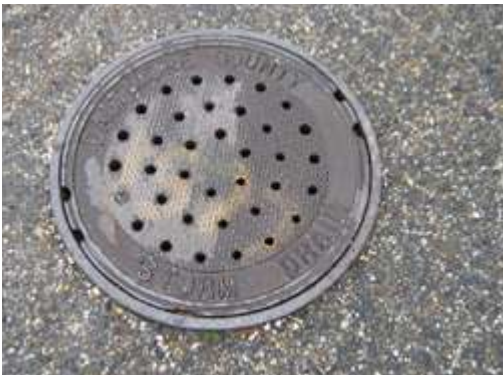
Miscellaneous

Comments **Active manhole...No connecting nodes on map 25U  
Storm drain cover.**

Wrong lid installed

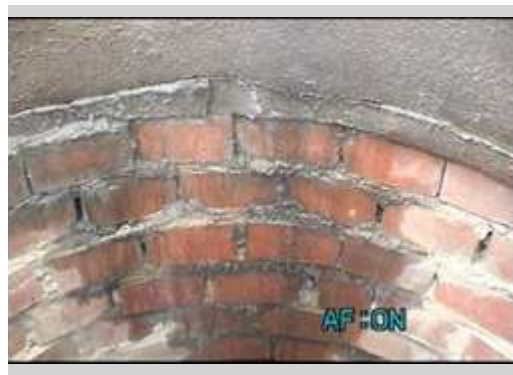
Defect 1

Infiltration: ☐ None ☐ Joint ☐ Cracks ☐ Mortar ☐ Roots ☒ **Wall**

Missing Mortar and Infiltration in Chimney

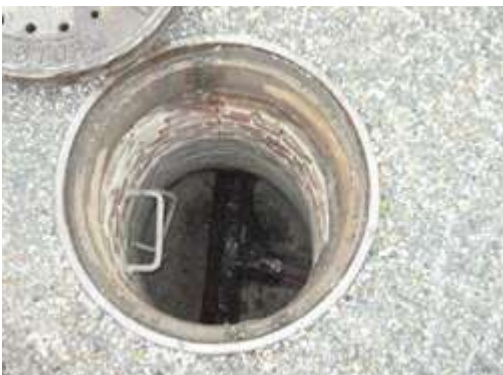
Defect 2

☒ **Leaks**

Frame Leaks

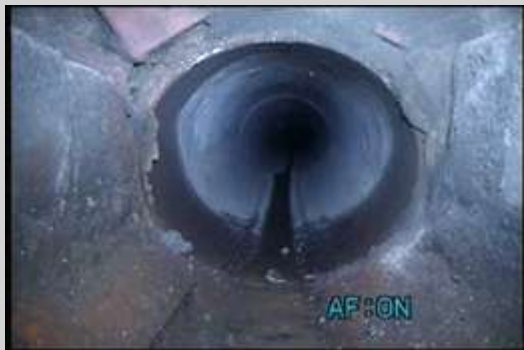
12 O'Clock Outflow

8 in. Circular Gravity Sewer  
Pipe Out @ 12 O'Clock

Pipe Height: **8.4** (in.) Rod and Bar (Angled)  
Pipe Material: **Clay** ☐ Pipe Lined  
Invert Depth: **6.76** (ft.) Flow Characteristics: **Slow**  
Deposits: ☒ None ☐ Mud ☐ Sludge ☐ Debris ☐ Grease  
Silt Depth: **0** (in.) Deposits Extent:  
Infiltration: **None** Pipe Seal Cond: **Sound**

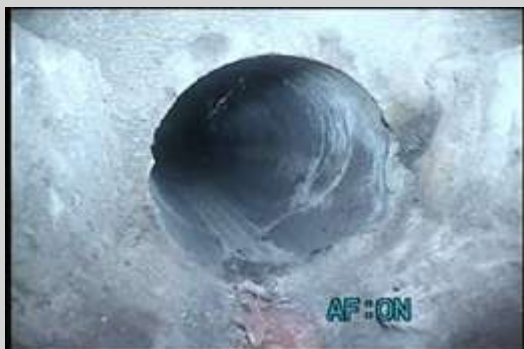
3 O'Clock Inflow

6 in. Circular Gravity Sewer  
Pipe In @ 3 O'Clock

Pipe Height: **6** (in.) Rod and Bar (Angled)  
Pipe Material: **Clay** ☐ Pipe Lined  
Invert Depth: **6.58** (ft.) Flow Characteristics: **Slow**  
Deposits: ☒ None ☐ Mud ☐ Sludge ☐ Debris ☐ Grease  
Silt Depth: **0** (in.) Deposits Extent:  
Infiltration: **None** Pipe Seal Cond: **Sound**

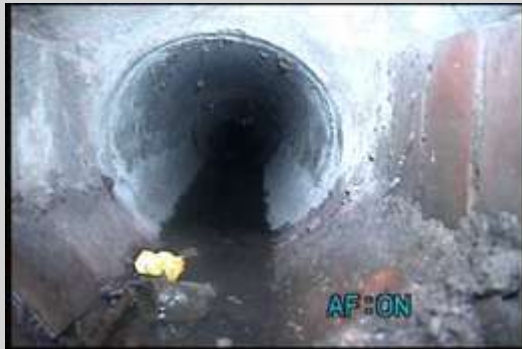
6 O'Clock Inflow

8 in. Circular Gravity Sewer  
Pipe In @ 6 O'Clock

Pipe Height: **8.4** (in.) Rod and Bar (Angled)

Pipe Material: **Clay** ☐ Pipe Lined

Invert Depth: **6.70** (ft.) Flow Characteristics: **Slow**

Infiltration: **None**

Pipe Seal Cond: **Sound**
